SERIOUS INCIDENT

Aircraft Type and Registration:	BAe ATP, SE-LPS	
No & Type of Engines:	2 Pratt and Whitney Canada PW126A turboprop engines	
Year of Manufacture:	1991 (Serial no: 2043)	
Date & Time (UTC):	9 April 2021 at 0519 hrs	
Location:	Ronaldsway Airport, Isle of Man	
Type of Flight:	Commercial Air Transport (Cargo)	
Persons on Board:	Crew - 2	Passengers - None
Injuries:	Crew - None	Passengers - N/A
Nature of Damage:	None reported	
Commander's Licence:	Airline Transport Pilot's Licence	
Commander's Age:	54 years	
Commander's Flying Experience:	5,415 hours (of which 2,964 were on type) Last 90 days - 44 hours Last 28 days - 20 hours	
Information Source:	AAIB Field Investigation

Synopsis

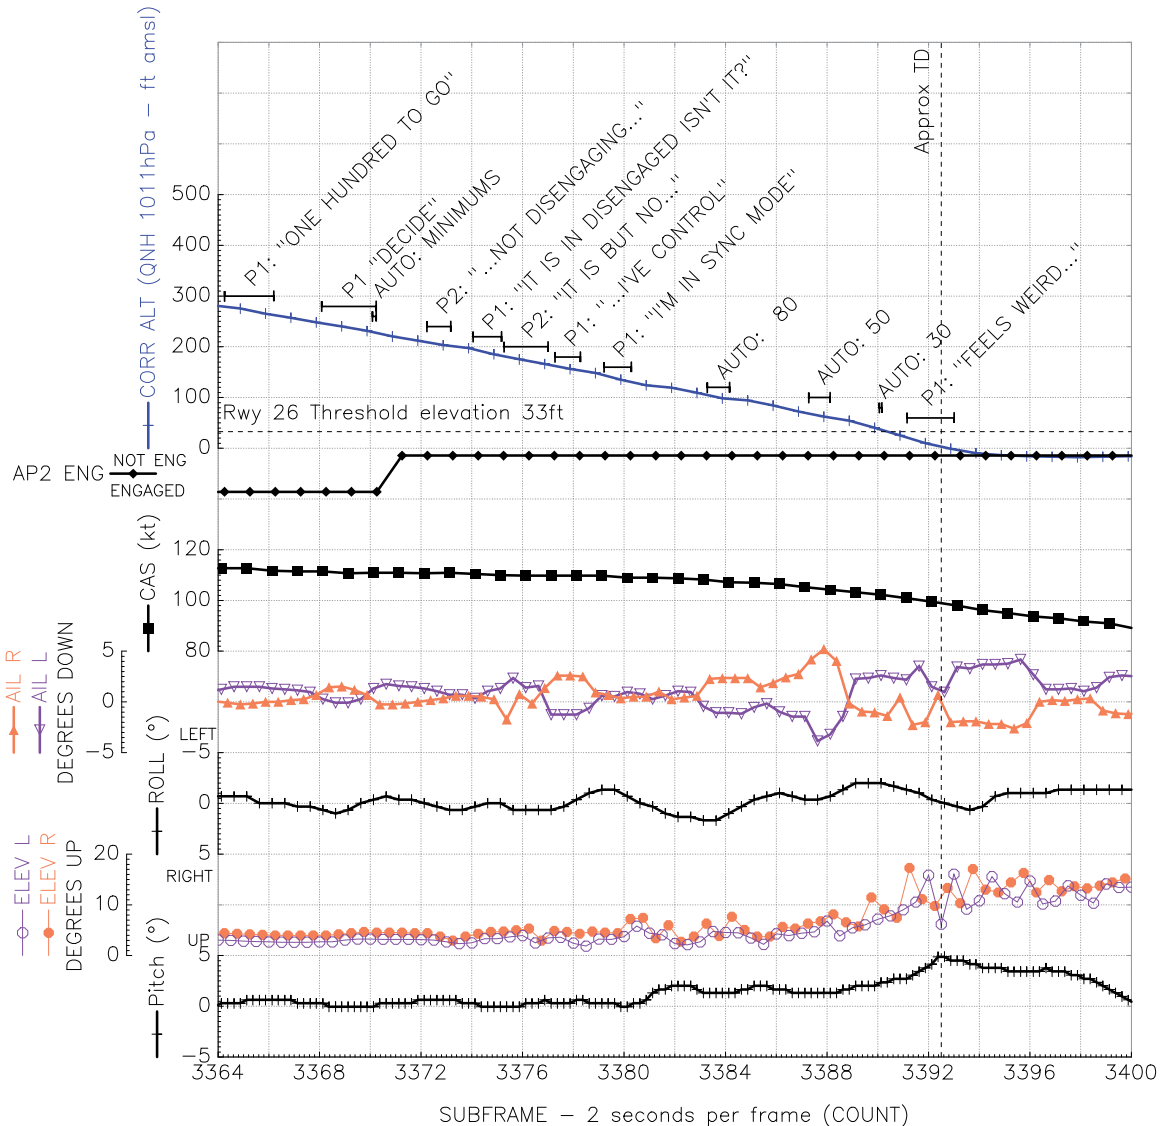
Figure 1
QAR and partial CVR extracts

The co-pilot was the PF during the descent. Passing through 250 ft amsl the commander called "DECIDE" and the automatic "MINIMUMS" call was triggered. The data shows that AP2 disengaged, followed by the co-pilot stating that it was "...NOT DISENGAGING..." No cavalry charge audio, normally associated with an autopilot disengagement, was captured by the CVR. This was followed by a brief discussion between the flight crew, during which the PF commented that he felt the AP had not disengaged. Passing approximately 150 ft amsl, the commander stated that he had control, and that he was "IN SYNC MODE". The descent continued and the aircraft landed normally. The commander stated that the aircraft "FELT WEIRD" but that he was in control.

After the aircraft landed, and whilst on the stand, the CVR recorded the crew reviewing the event. The co-pilot stated that he had attempted to disengage the autopilot using the 'button' and also the trim but it had not disengaged. He recalled that he tried to roll the aircraft but that he felt resistance against his attempt to move the control column. The commander stated that it had showed DISCONNECTED on his side.

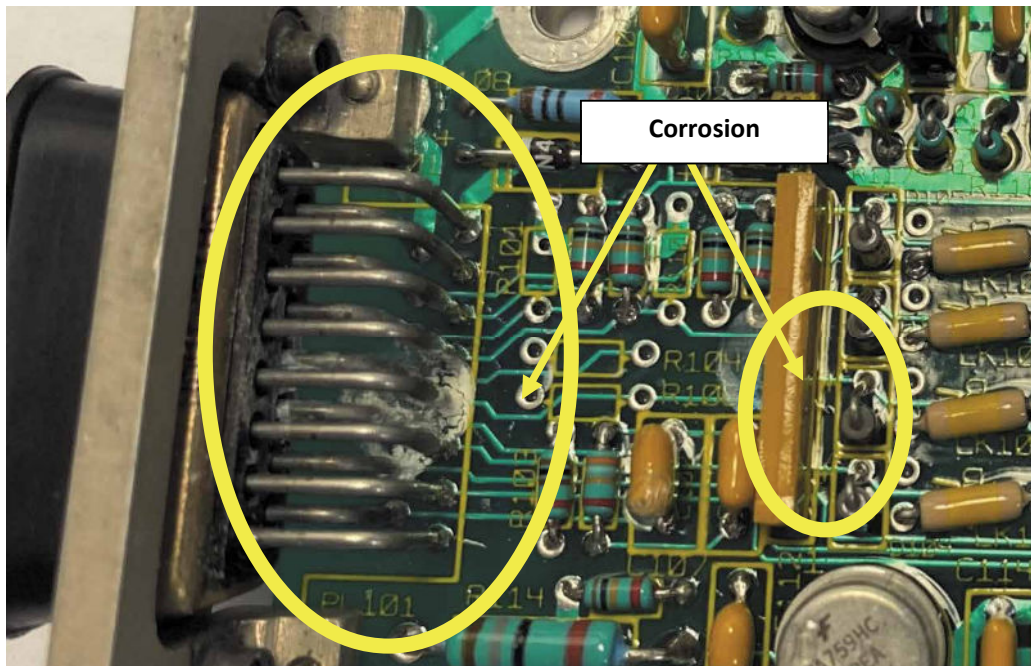
Figure 5

No faults were found when the warning unit was tested. It was dry when disassembled, but corrosion deposits were found on one of the three printed circuit boards (PCBs). Most of

the corrosion was in the area where the external electrical connector was soldered to the PCB, but deposits were also found on other areas of the circuit board (Figure 5).

Corrosion deposits inside the audio warning unit

The investigation concluded that the anomalies with the audio warnings were probably associated with corrosion and moisture caused by water ingress through the DV windows.

- Install the extended side trim panels on all their ATP aircraft and repair any damaged panels.
- Waterproof the side-console switches on all their ATP aircraft.
- Check the rigging of every ATP DV window to make sure that they close correctly.
- Investigate the feasibility of remounting the audio warning unit and installing a drip shield to avoid moisture entering the unit from the top.

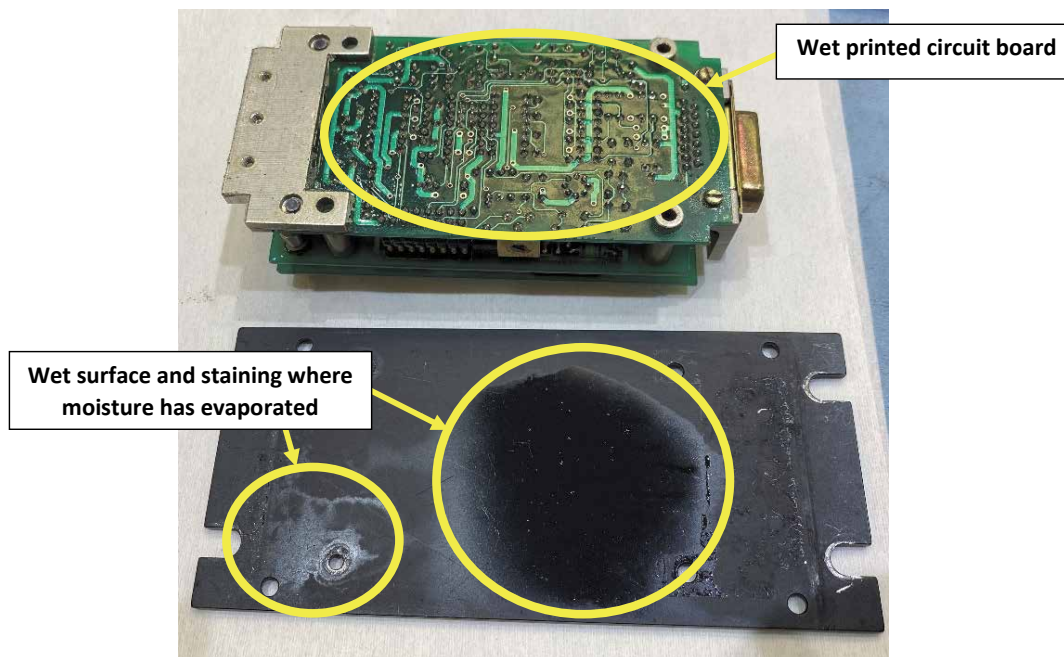
Figure 7

As the audio irregularities on SE-MAJ were very similar to those on SE-LPS, the audio warning unit from SE-MAJ was returned to the AAIB for further investigation. Visual examination found the external condition to be good but when the external cover was removed the internal components were found to be wet and corrosion was seen on one of the PCBs (Figure 7). This examination was carried out seven days after the occurrence of 2 December 2021, so it is possible that the unit had partially dried out in the intervening time.

Visible moisture in the audio warning unit

Corrosion was also found within the warning unit fitted to SE-MAJ and the PCBs inside were wet. The combined effect of the corrosion and moisture cannot be readily assessed. However, given the similarities between the symptoms on both aircraft, it is likely that this contributed to, or caused, the extended duration of the altitude alerts and the repeated cavalry charge warnings on SE-LPS after it landed. The DV windows, which can be opened when the aircraft is on the ground, are known to be susceptible to water ingress. Previous SBs have been issued to reduce the likelihood of aircraft equipment being affected by

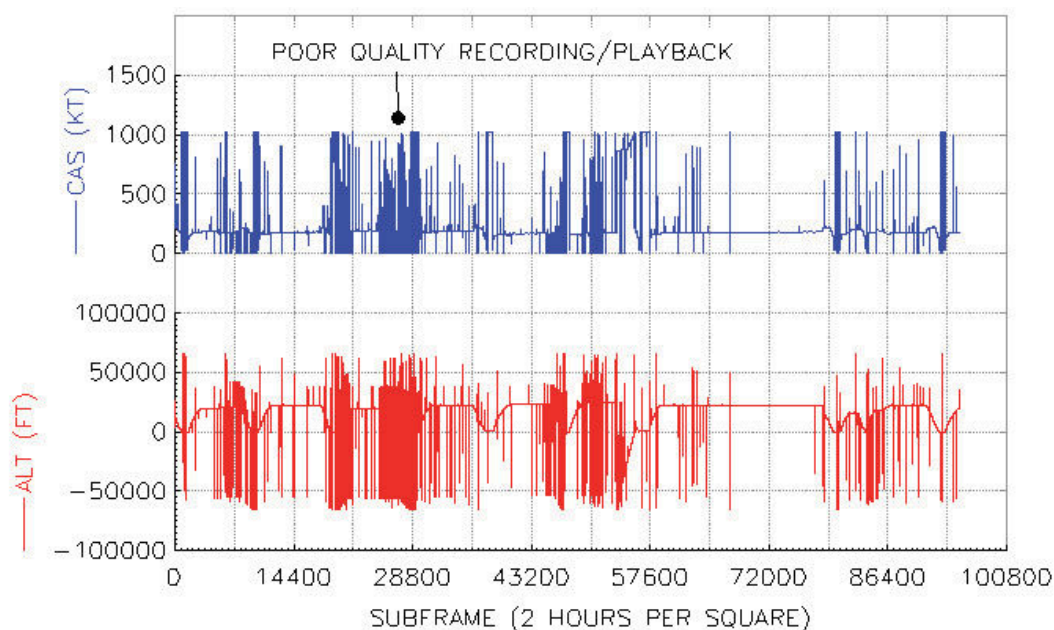
Figure 8

The FDR fitted to SE-LPS was a model PV1584 which records the data on a magnetic tape. These recorders can suffer from quality issues, resulting in parameter error rates that vary throughout the recording (Figure 8). Errors are expected to occur when recorders

stop and start between flights. Additional errors are likely to occur even on a good quality installation.

Example parameters illustrating quality issues of magnetic tape
FDR recording from SE-LPS

It is recommended that the Civil Aviation Authority review the use of magnetic tape flight data recorders used in aircraft operated by UK Air Operator Certificate holders and establish if there is a practical way to comply with the ICAO requirement to cease their use.

It is recommended that the Civil Aviation Authority require that magnetic tape flight data recorders, used in aircraft operated by UK Air Operator Certificate holders, comply with the Civil Aviation Authority Specification No 10, regarding the error rate requirements, by checking the complete recording rather than by undertaking a sample check.

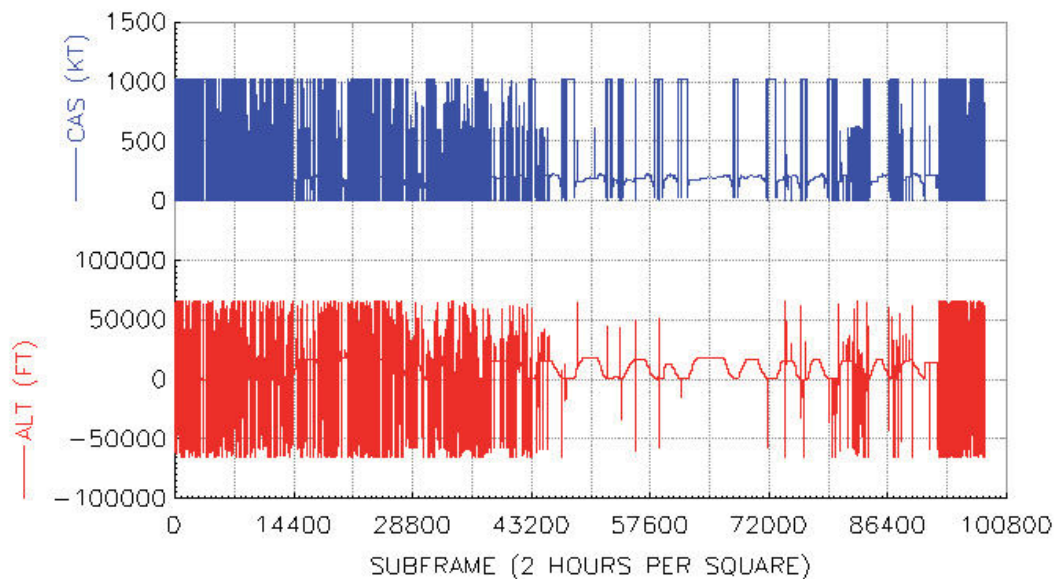
Figure 9

SE-MAJ was also fitted with the same model of FDR as SE-LPS, and the recording from its occurrence flight also had significant quality issues (Figure 9).

Example parameters illustrating quality issues of magnetic tape FDR recording, from SE-MAJ.
