SERIOUS INCIDENT

Aircraft Type and Registration:	BAe ATP, SE-LPS	
No & Type of Engines:	2 Pratt and Whitney Canada PW126A turboprop engines	
Year of Manufacture:	1991 (Serial no: 2043)	
Date & Time (UTC):	9 April 2021 at 0519 hrs	
Location:	Ronaldsway Airport, Isle of Man	
Type of Flight:	Commercial Air Transport (Cargo)	
Persons on Board:	Crew - 2	Passengers - None
Injuries:	Crew - None	Passengers - N/A
Nature of Damage:	None reported	
Commander's Licence:	Airline Transport Pilot's Licence	
Commander's Age:	54 years	
Commander's Flying Experience:	5,415 hours (of which 2,964 were on type) Last 90 days - 44 hours Last 28 days - 20 hours	
Information Source:	AAIB Field Investigation

Synopsis

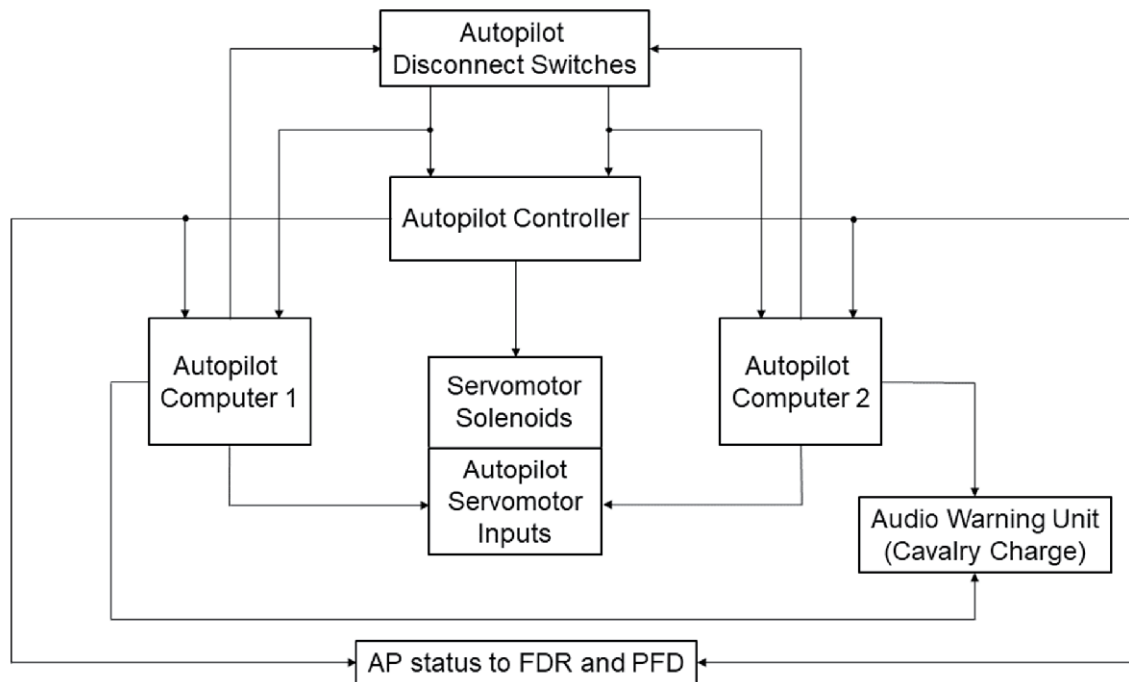
Figure 6

The autopilot disconnect switches are connected to the autopilot controller, which monitors their status and uses analogue logic gates to control the autopilot computers and servo solenoids (Figure 6).

Simplified autopilot schematic (not all components and interactions are depicted)
